# STEELMASTER 2021

## Non-Sticking Furnace Rolls for Continuous Galvanizing & Continuous Annealing Lines

*Jean Michel Arbiol, Marc Blumenau*  
contact: [marc.blumenau@thyssenkrupp.com](mailto:marc.blumenau@thyssenkrupp.com)

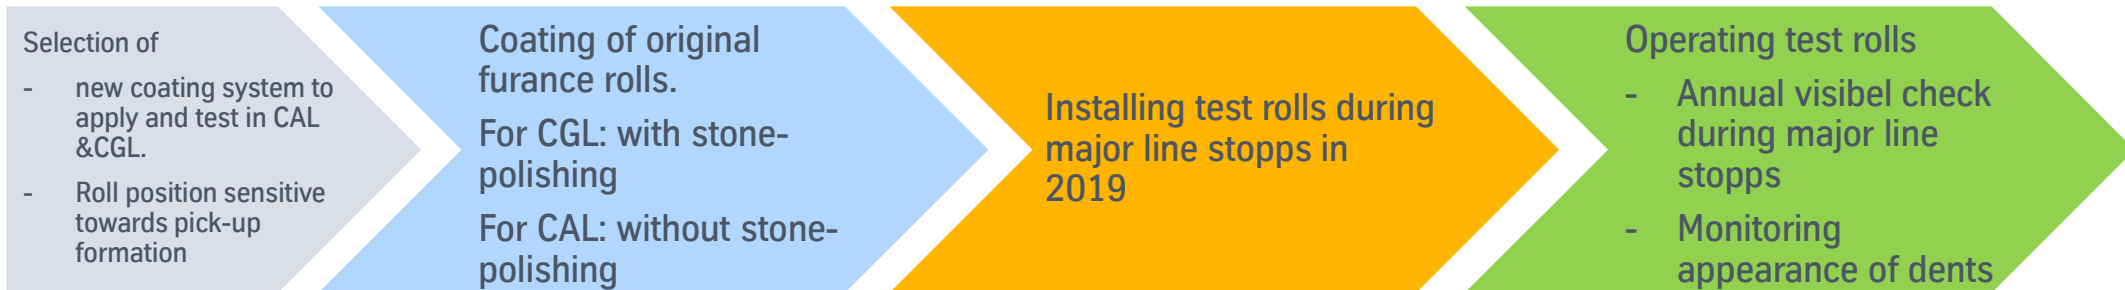
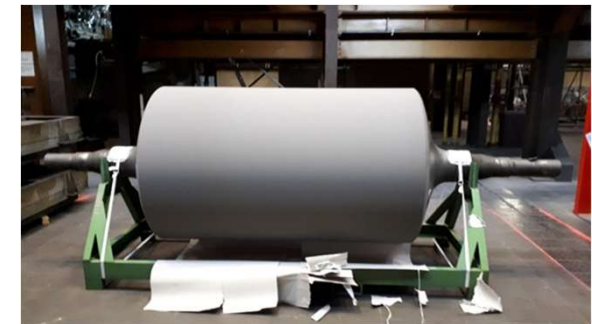
# Preparation for First Industrial Trials

*Seleled coating:*  
*WC-CrC-Ni 73/20/7*

CGL & CAL selected a roll position after the cooling section where pick-ups mainly appear to test the new coating
